BULGARIAN FIGHTER COLOURS 1919–1948

Vol. 1

Rainbow No 9136

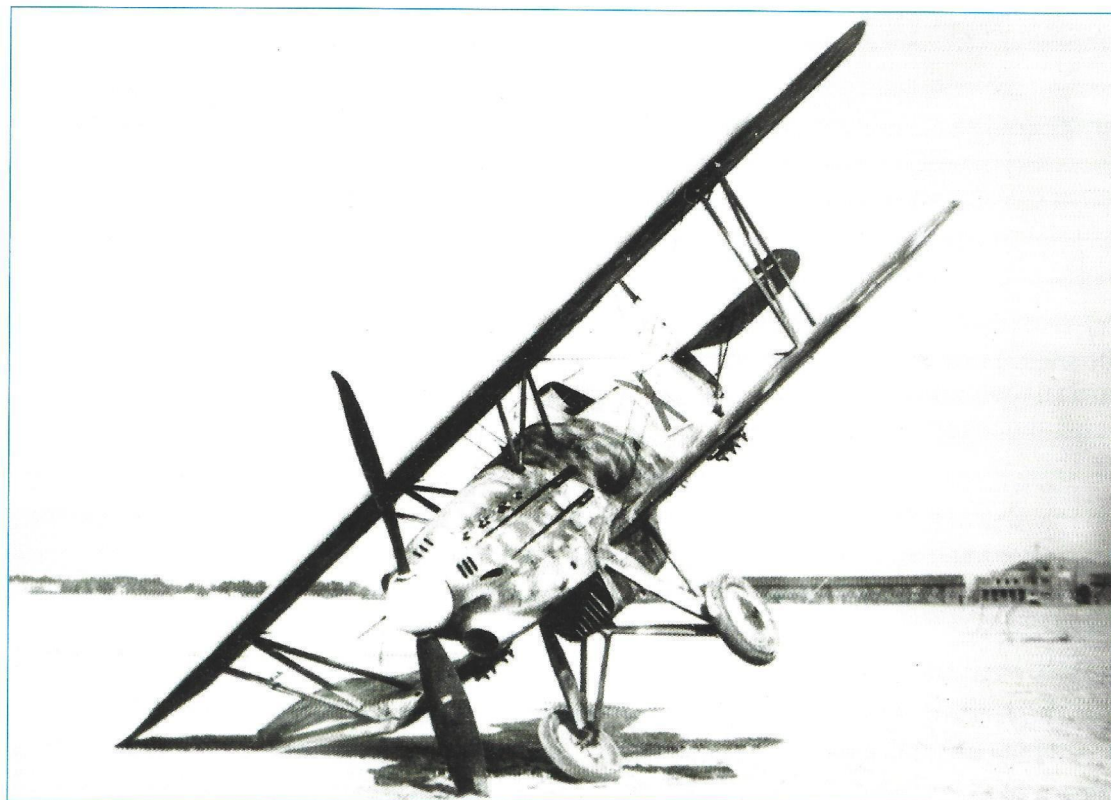
Even after hostilities ceased and the warplanes of Air Eskadra returned to their peacetime bases, flying incidents did occur, as depicted in this photo showing the Avia biplane in all too familiar 'nosed-on' position, which happened due to its narrow undercarriage wheel span. This particular Dogan wearing the peculiar late war squiggle camouflage scheme does not have the underside of the engine cowling painted in dark green; it kept the original light grey colour. The white triangle is on the mid-fin; however, the serial number is unfortunately illegible.

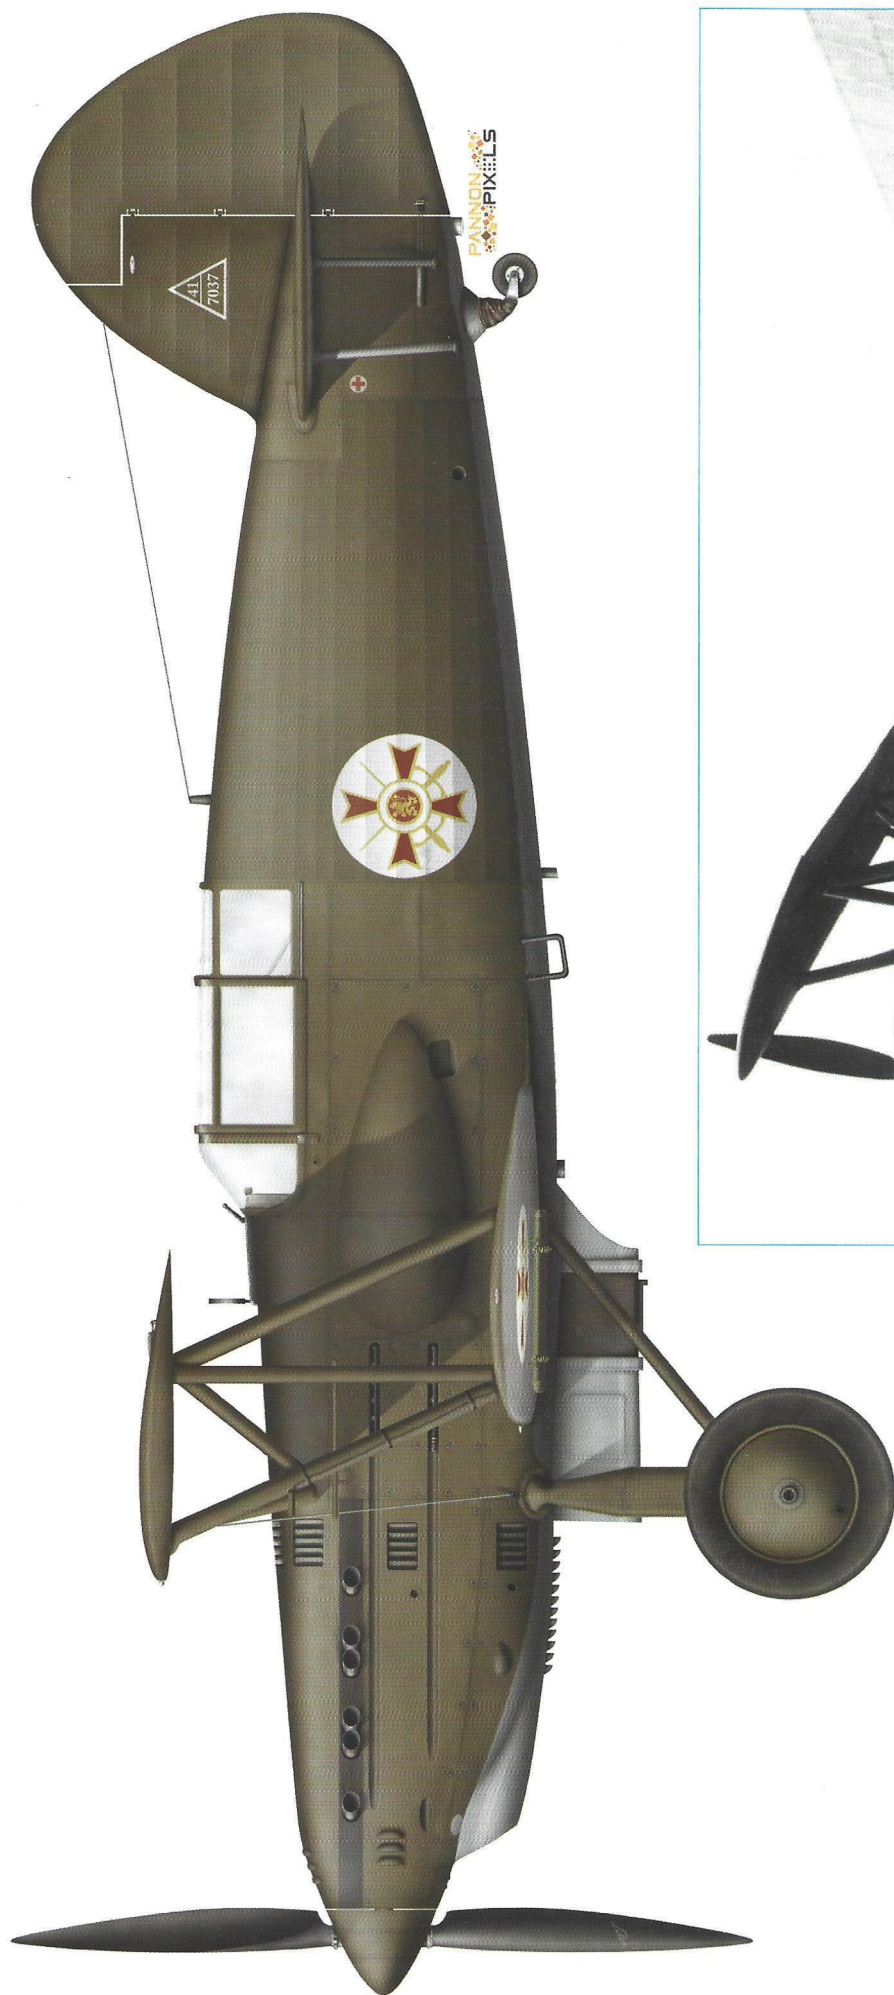
Avia B.534-V Dogaň, 41/7037, DSF Aviation Workshop, Bozhurishite, February 1940. Camouflage colours: Czechoslovak khaki green on upper surfaces, over light grey or shiny metal (silver dope) on under surfaces. Tsarist roundel type VNVV marking on fuselage sides and wing surfaces, in six positions.

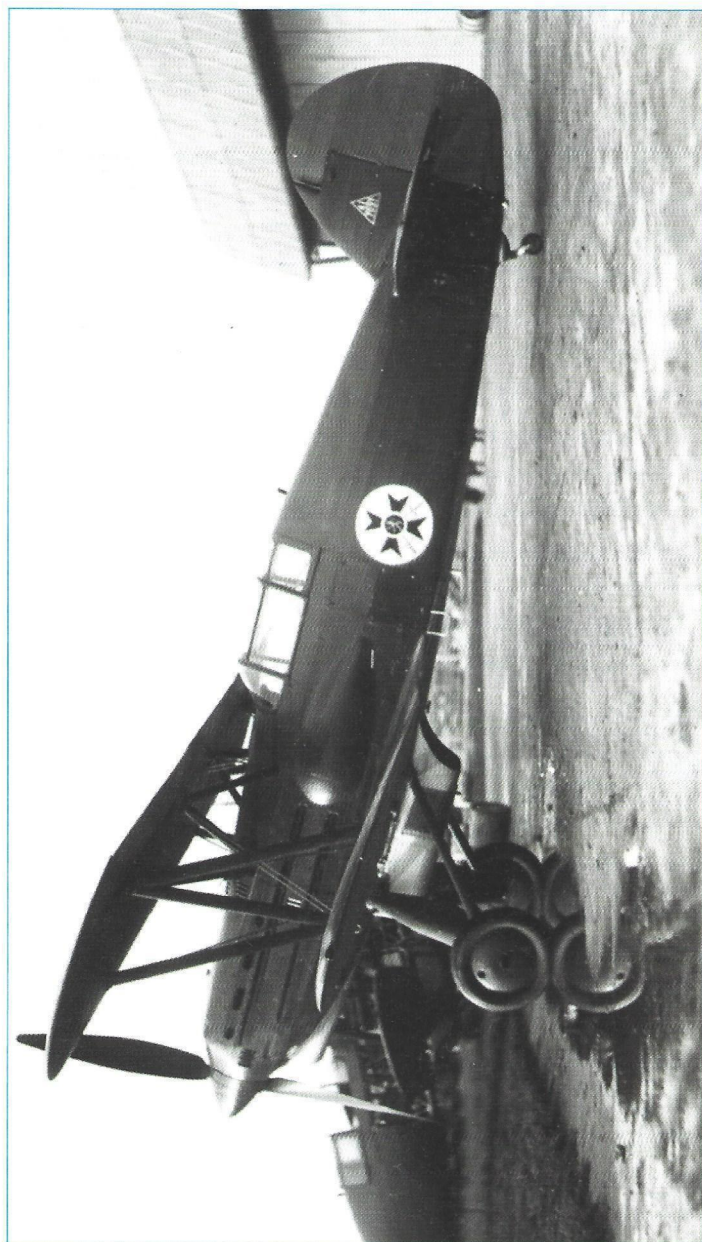
A recently assembled Avia B.534 Series V, NN 41/7037, parked in front of the DSF Workshop at Bozhurishite, in early 1940. The roundel type military marking was freshly applied on the fuselage sides, but not yet on the wings.

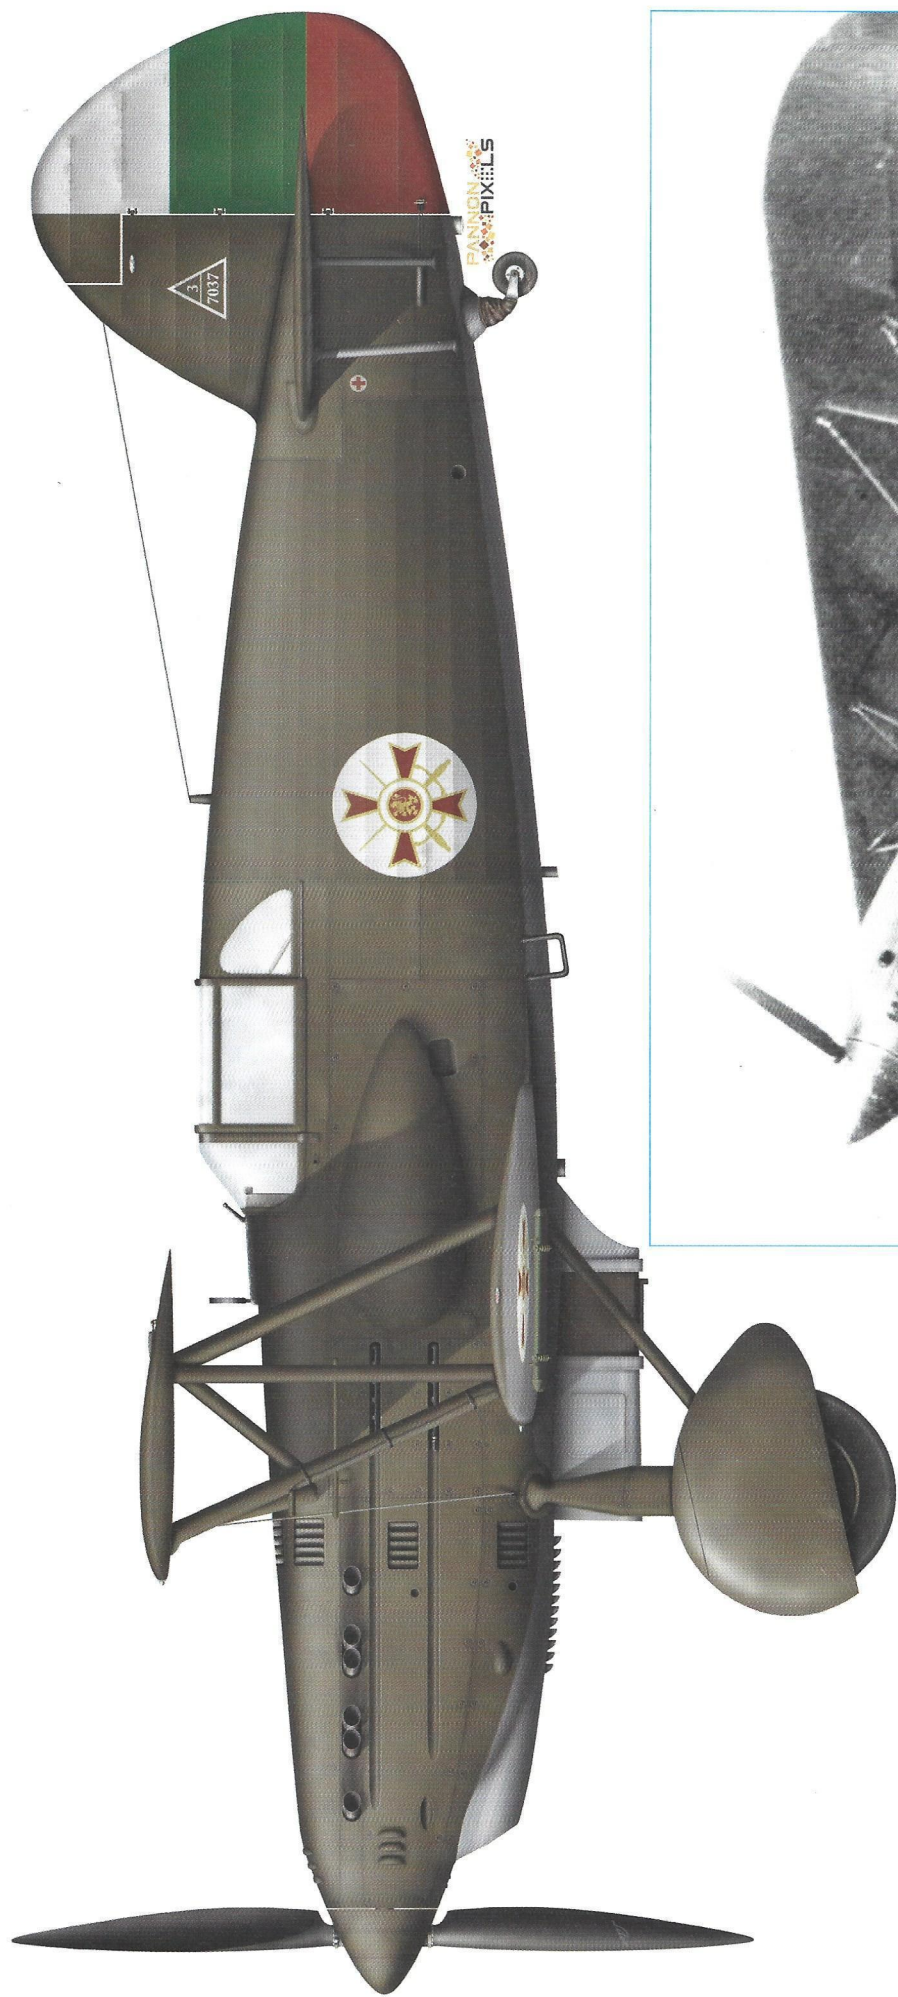
Avia B.534-IV Dogan, 3/7037 (unconfirmed), 2. Iztrebitelen Onlyak, Marno Pole/Karlovo, April 1940. Camouflage colours: Czechoslovak khaki green on upper surfaces, over shiny metal (silver dope) on under surfaces. Tsarist roundel type VNVV marking on fuselage sides and wing surfaces, in six positions. White-Green-Red tricolour rudder.

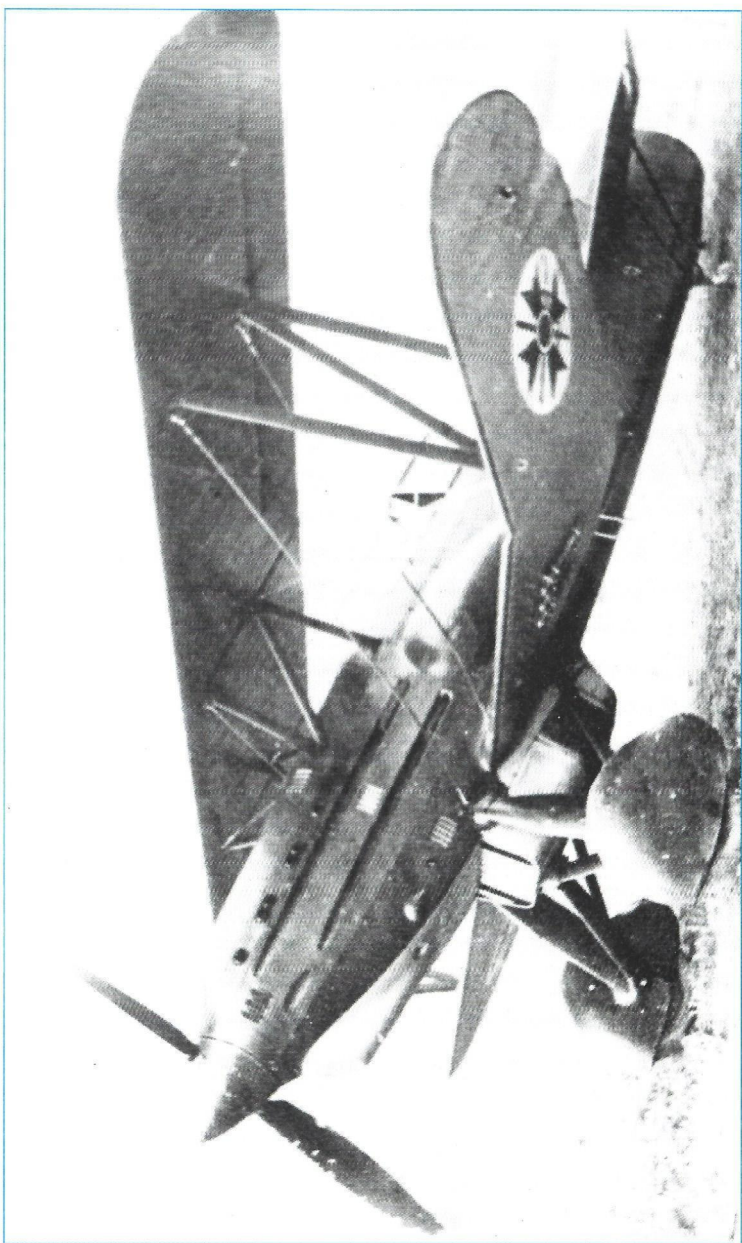
Most probably one of the very first accidents involving an Avia B.534 in Bulgaria is depicted. Unfortunately, no details are known, including the date. However, based on the roundel type marking, it must have happened prior to June 1940. A careful onlooker may notice that the roundel barely visible on the starboard wing undersurface (on the far side) appears to be positioned inside the N-shape wing struts, while the roundel visible on the port wing undersurface (closer to the camera) is apparently positioned outside the N-shape wing strut, raising the suspicion that the photo was doctored. The rudder is already painted in white-green-red, i.e. Bulgaria's national colours. The paint had chipped off the propeller blades in many places.

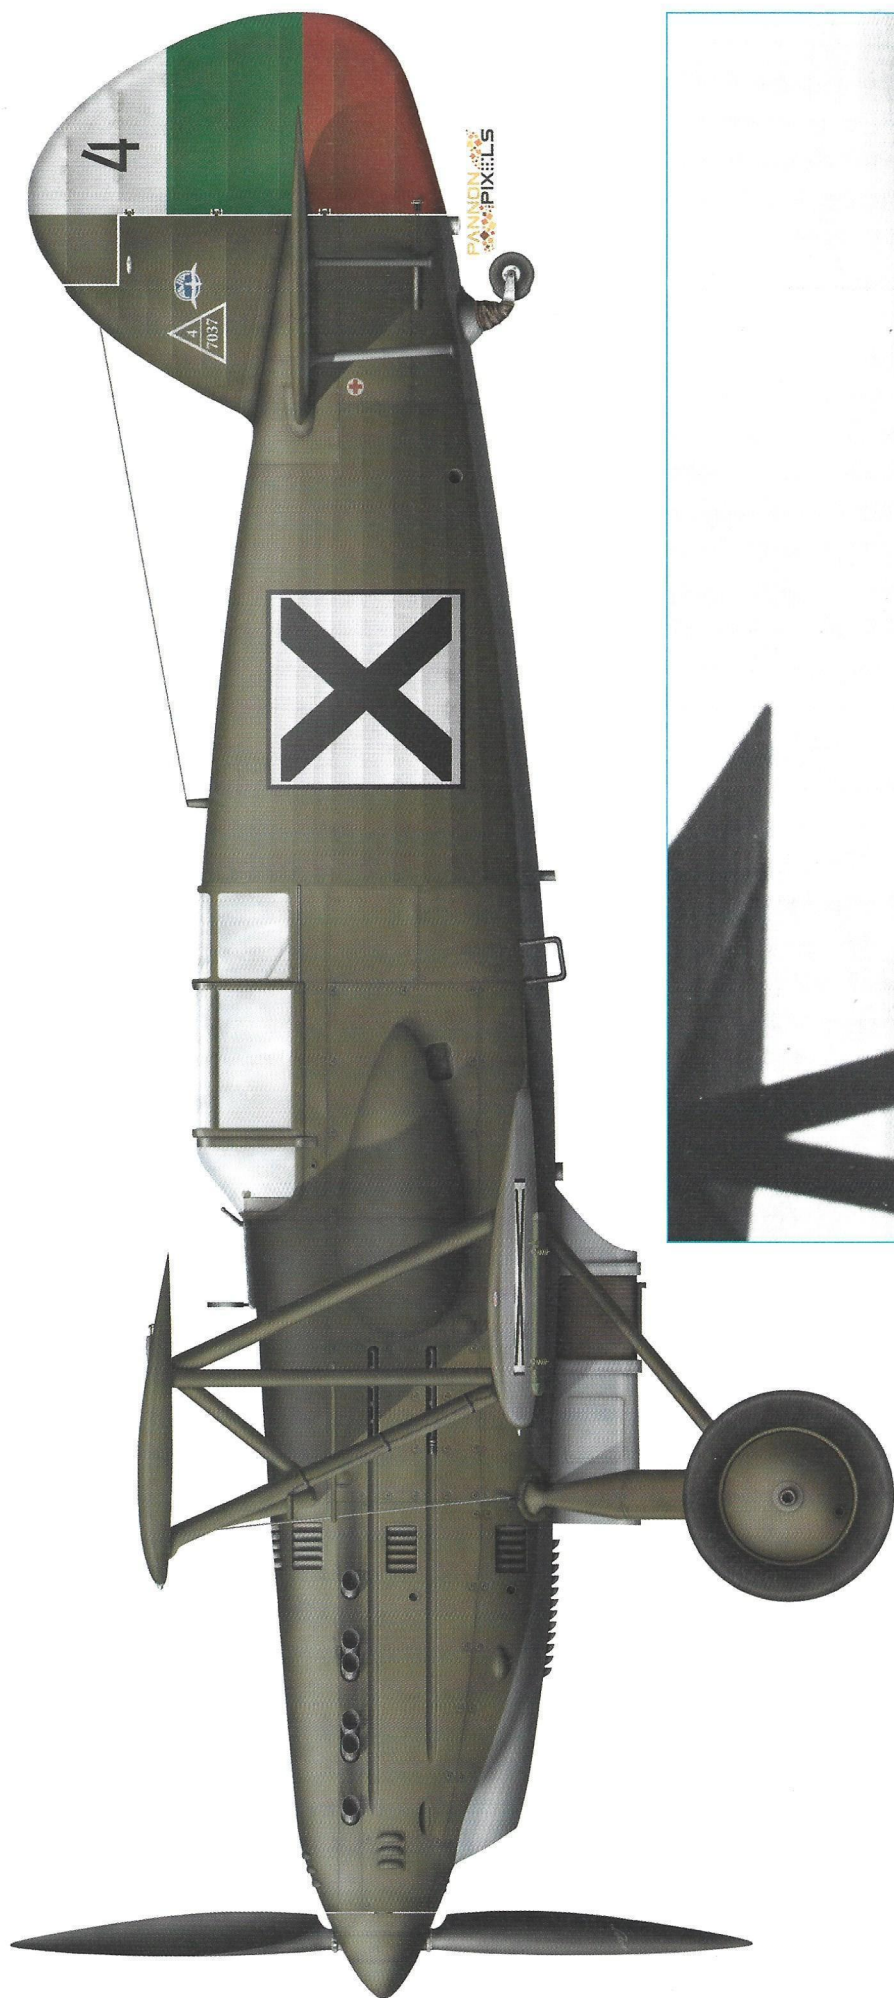
Avia B.534-V Dogan, 4/7037, 1st Army Air Polk, Bozhurishite, mid-1940.
Camouflage colours: Czechoslovak khaki green on upper surfaces, over light grey, or shiny metal (silver dope) on under surfaces. St. Andrew cross type VNVV marking on fuselage sides and wing surfaces, in six positions. White-Green-Red tricolour rudder. Black serial number on rudder top.

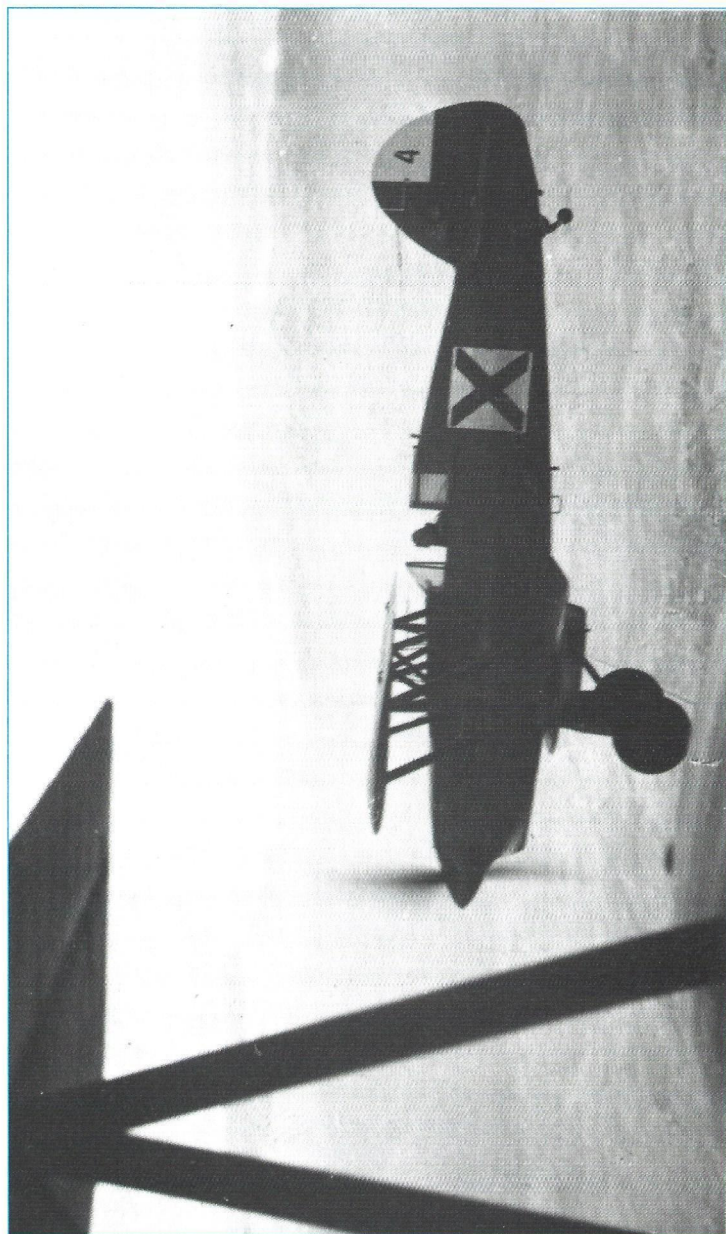
Fine in-flight study of Dogan No. 4, an Avia B.534 Series V, taken in mid-1940, with a majestic mountain range providing picturesque background. This time, the aircraft's serial number shows up on the airframe, in this case on the rudder top, in the white segment of the Bulgarian tricolour. Most 'old school' pilots preferred to fly with open cockpit, reportedly 'to hear the engine's roar better'.

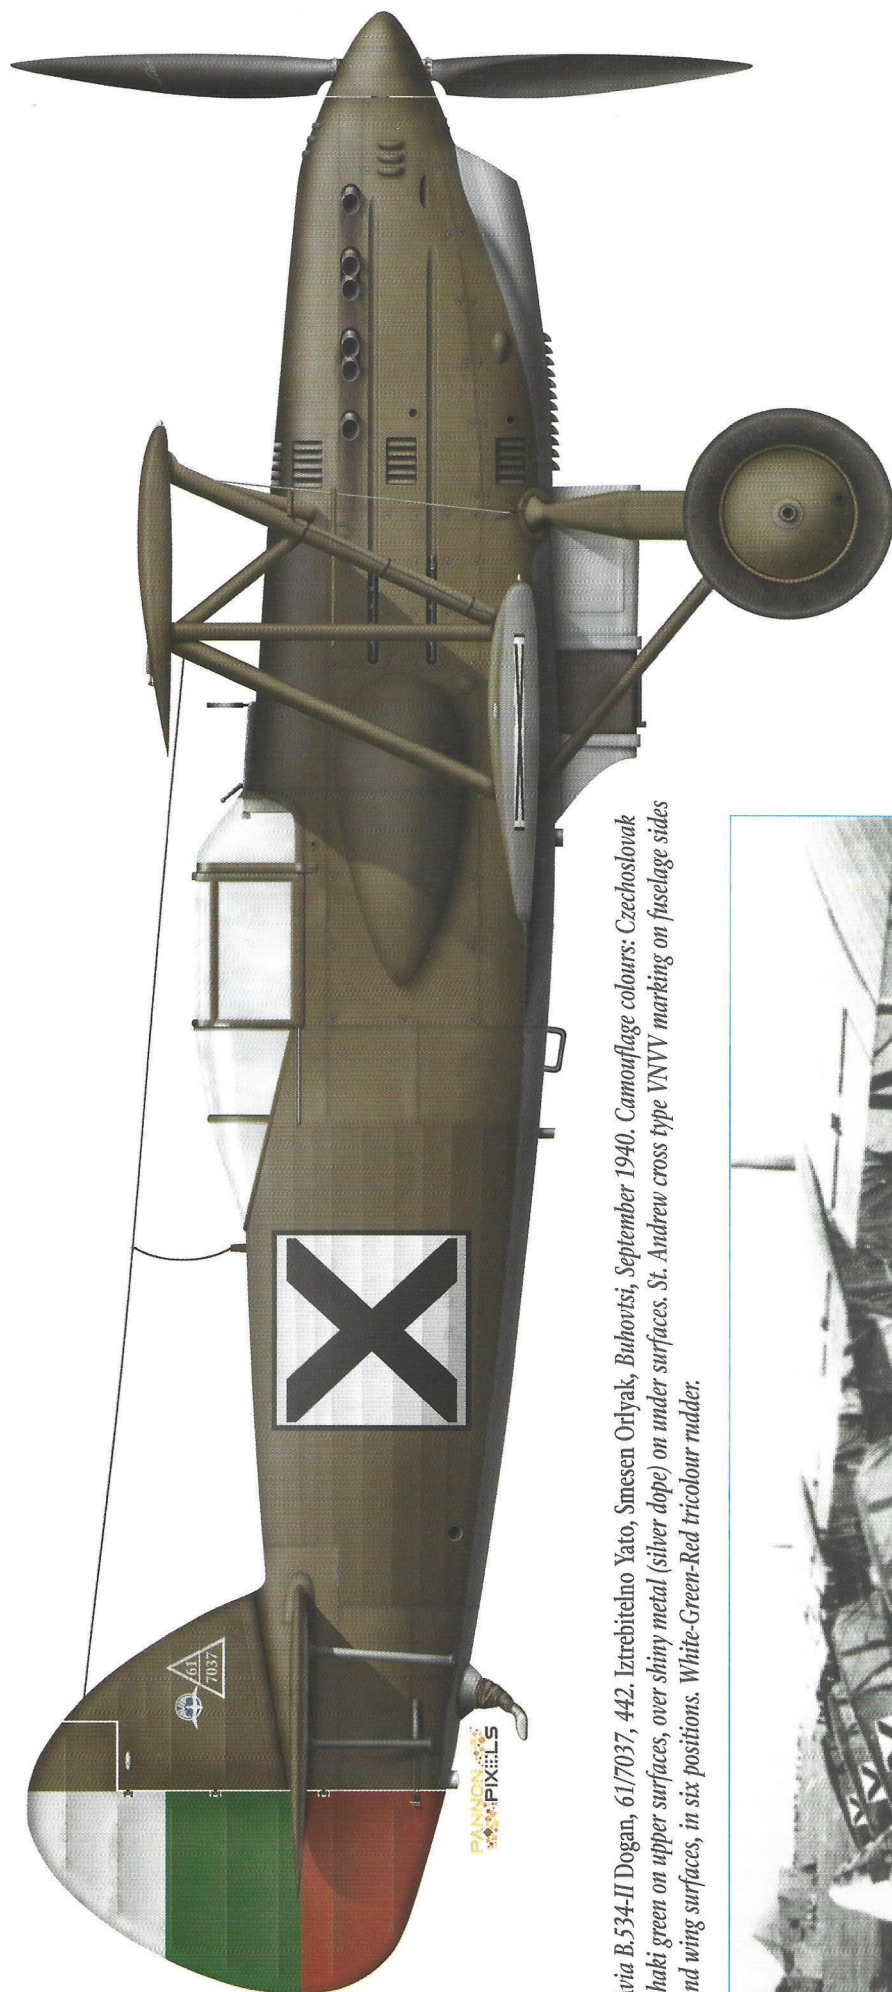
Avia B.534-II Dogan, 61/7037, 442. Izrebitelno Yato, Smesen Orlyak, Buhovtsi, September 1940. Camouflage colours: Czechoslovak khaki green on upper surfaces, over shiny metal (silver dope) on under surfaces. St. Andrew cross type VNVV marking on fuselage sides and wing surfaces, in six positions. White-Green-Red tricolour rudder.

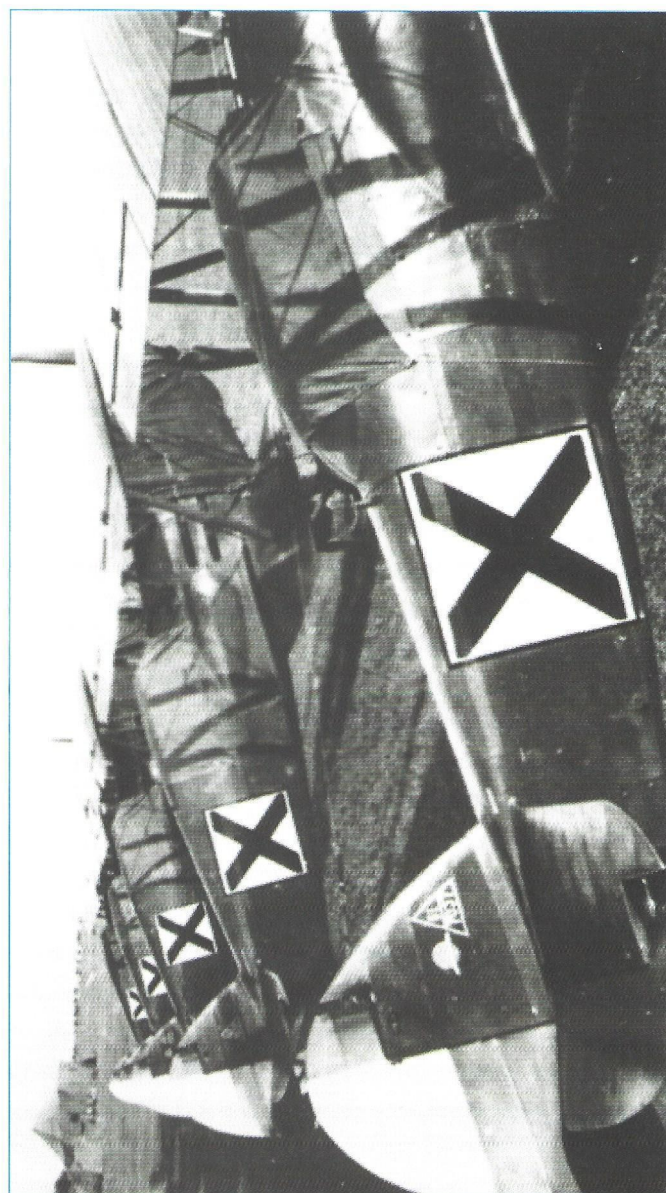
This snapshot taken at Buhovtsi airfield shows five Dogans lined up in mid-September 1940 (same location and date as the photo featured on page 154). Nearest to the camera is a rarely seen Avia B.534 Series II, easily identified by the shorter fuselage spine aft the cockpit and the 'bubble-type' retrofit cockpit. The Nomenklaturen Nomer (NN) of this aircraft, visible on the fin, just in front of the factory emblem, is 61/7037. This particular aircraft was involved in an accident due to piloting error that happened on Dabne landing ground, on 13 February 1941. The unlucky pilot was Por. Chudomir M. Toplodolski of the 6th Fighter Regiment – future third ranking top fighter pilot. Based on another photo taken at Buhovtsi landing ground, most probably at the same time (see page 154 top), it appears that the engine cowling of this Avia B.534-II version may have been upgraded to the IV standard. It is known that this aircraft was damaged in the autumn of 1938 and was repaired by next summer. There is an – unproven – possibility that the airframe received the standard engine cowling during the overhaul (see photo on page 154, top). This version is shown on the colour artwork, with a caveat.

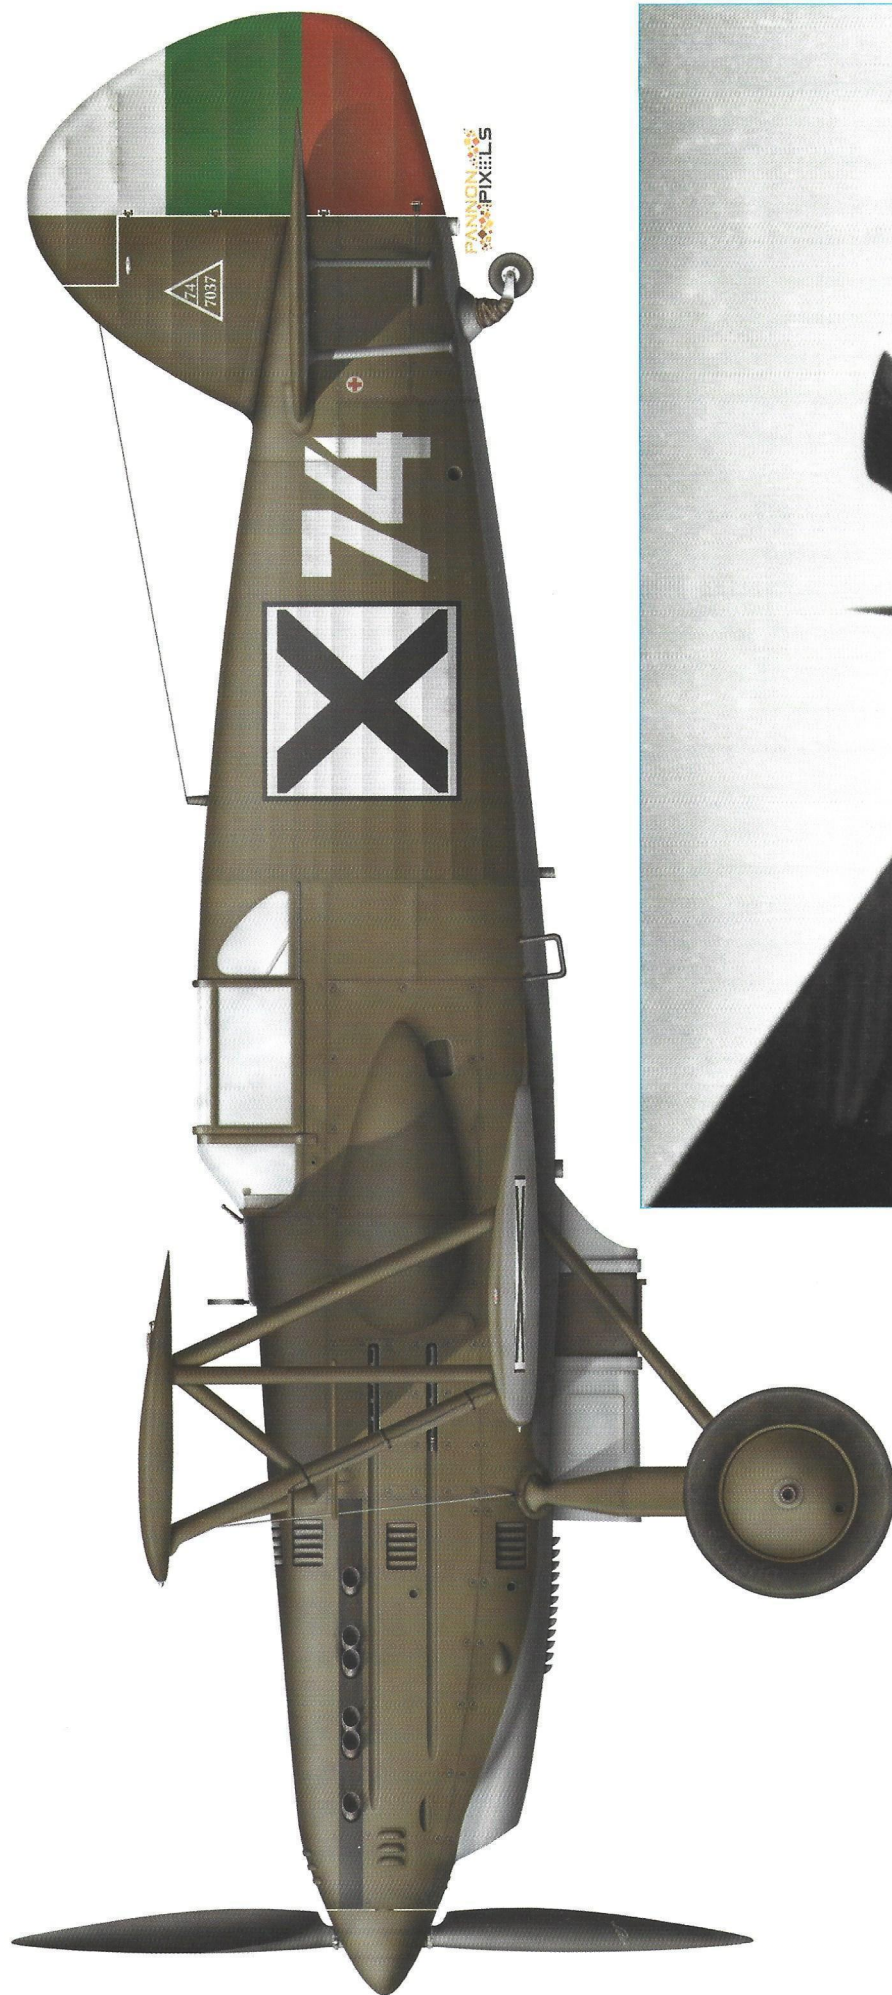
Avia B.534-IV Dogan, 74/7037 (c/n 387), 1st Army Air Polk, Bozhurishite, early 1941. Camouflage colours: Czechoslovak khaki green on upper surfaces, over light grey, or shiny metal (silver dope) on under surfaces. St. Andrew cross type VNVV marking on fuselage sides and wing surfaces, in six positions. White-Green-Red tricolour rudder. White serial number on rear fuselage.

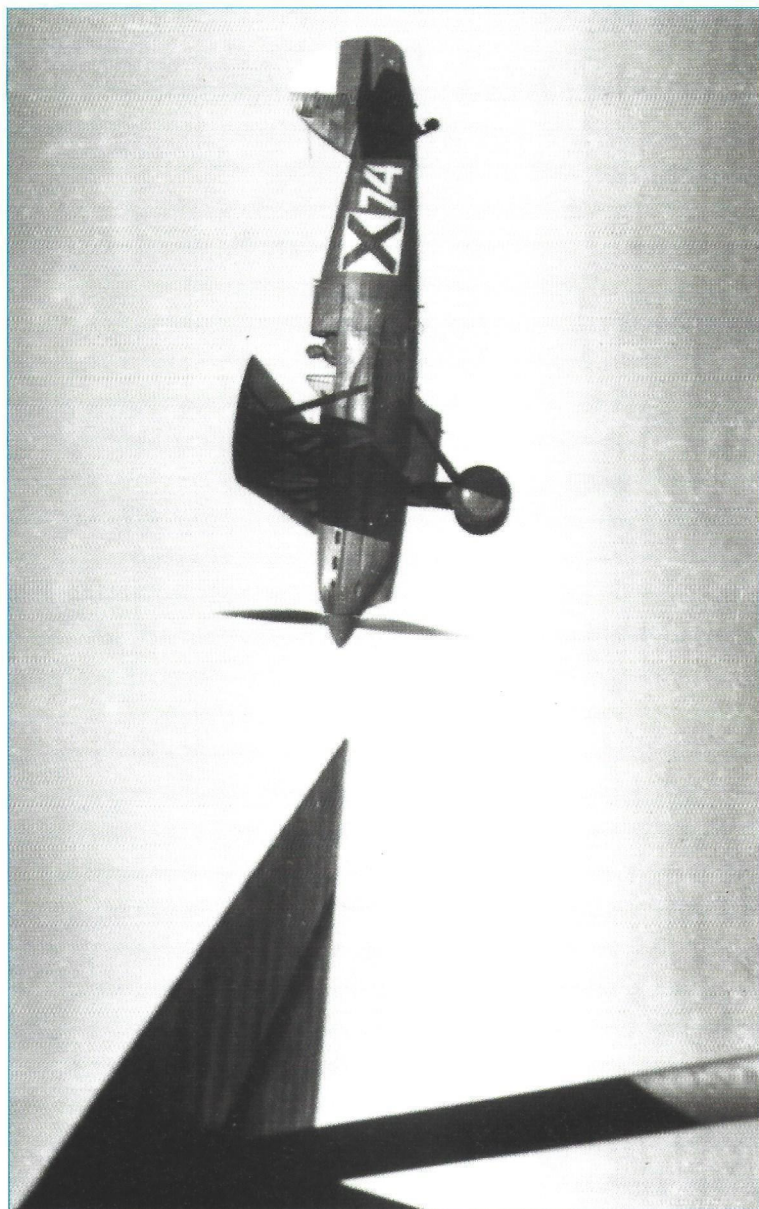
Majestic in-flight shot of Dogan No. 74, taken in early 1941. The rudder is still adorned with the Bulgarian national colours, which would soon disappear, giving way to the Axis yellow, along with other similarly coloured identification features. The photo is not clear enough to positively determine if the rearward tapering red fuselage flash was applied or not. The serial (board) number is displayed on the rear fuselage, in large white numerals. This is the location where it would stay until shortly after Bulgaria's about-face and exit of the Axis Camp in September 1944. The apparently tall pilot would certainly had to lower his head if he wanted to close the cockpit canopy.

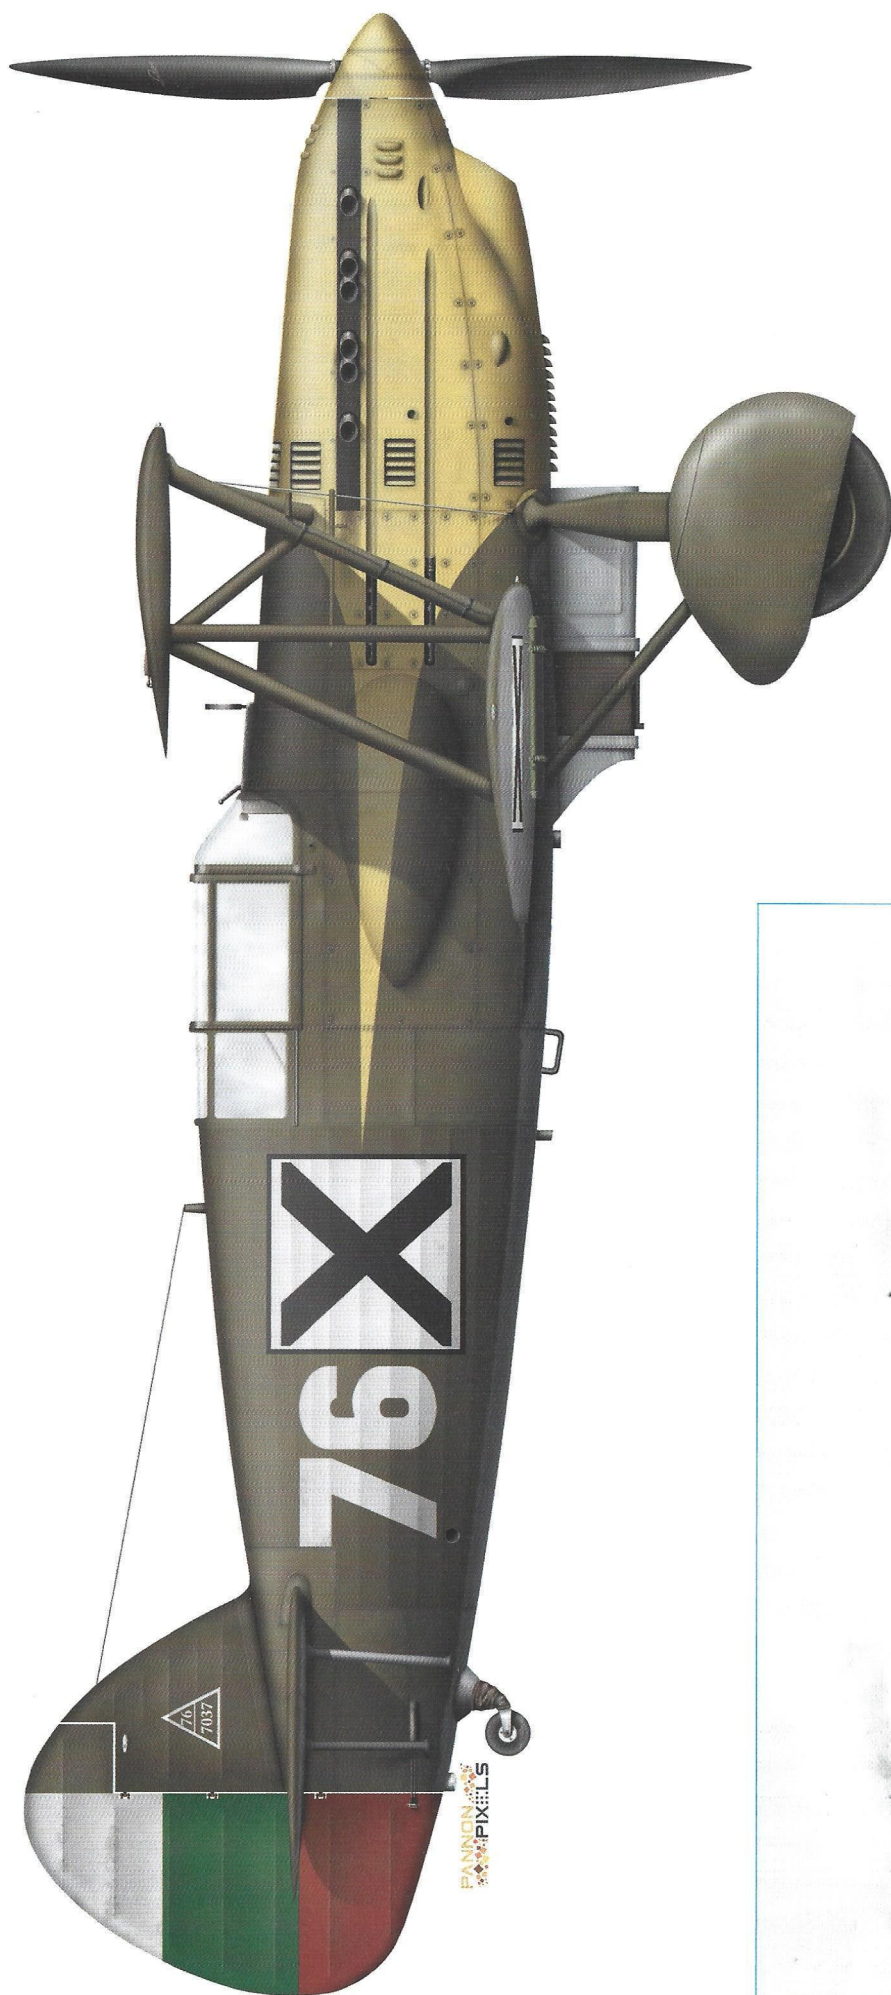
Avia B.534-V Dogan, 76/7037, 1st Army Air Polk, Bozhurishte, early 1941. Camouflage colours: Czechoslovak khaki green on upper surfaces, over light grey, or shiny metal (silver dope) on under surfaces. St. Andrew cross type VNVV marking on fuselage sides and wing surfaces, in six positions. Yellow spinner, engine cowling, continued in a rearward tapering flash along the fuselage. White-Green-Red tricolour rudder. White serial number on rear fuselage.

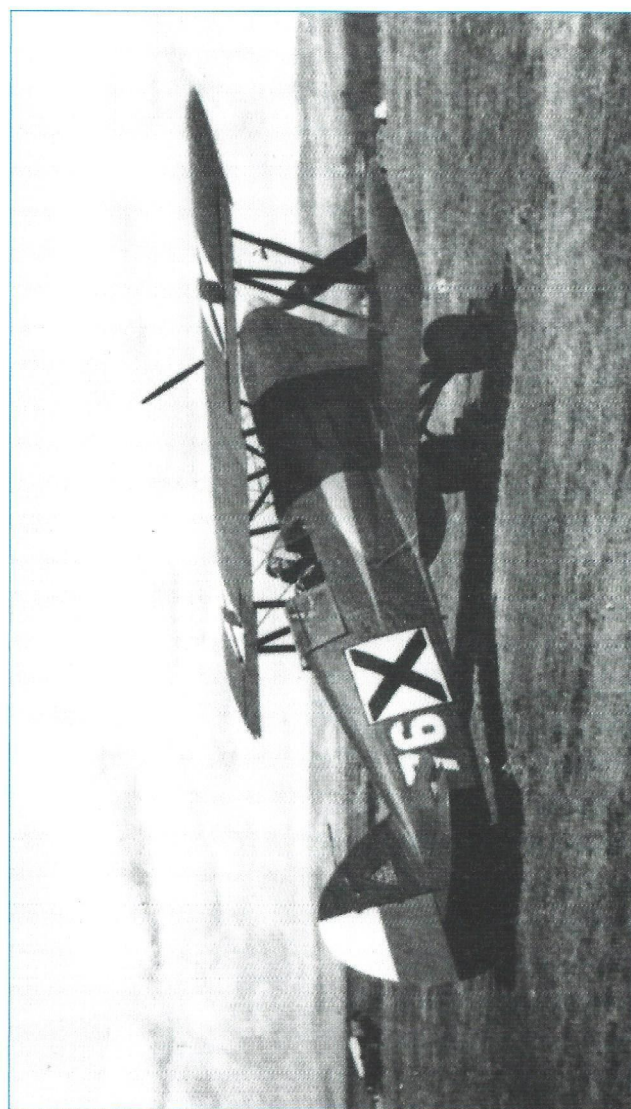
In this photo of No. 76, taken just weeks later than the previous one depicting No. 74, the following marking and painting combination is displayed: tricolour painted rudder, rearward tapering yellow fuselage flash originating from the similarly painted cowling, yellow spinner. The engine cowling is covered by a tarpaulin, leading the inattentive onlookers to believe the engine area was not painted yellow, as inaccurate artwork published in various locations shows this particular machine. The absence of typical yellow Axis recognition features (rudder, elevators, fuselage band, possibly wingtips) points to the probability that this photo was taken prior to April 1941, when these ID markings were introduced. The main wheel covers could be easily removed on the field, when the runway was muddy.

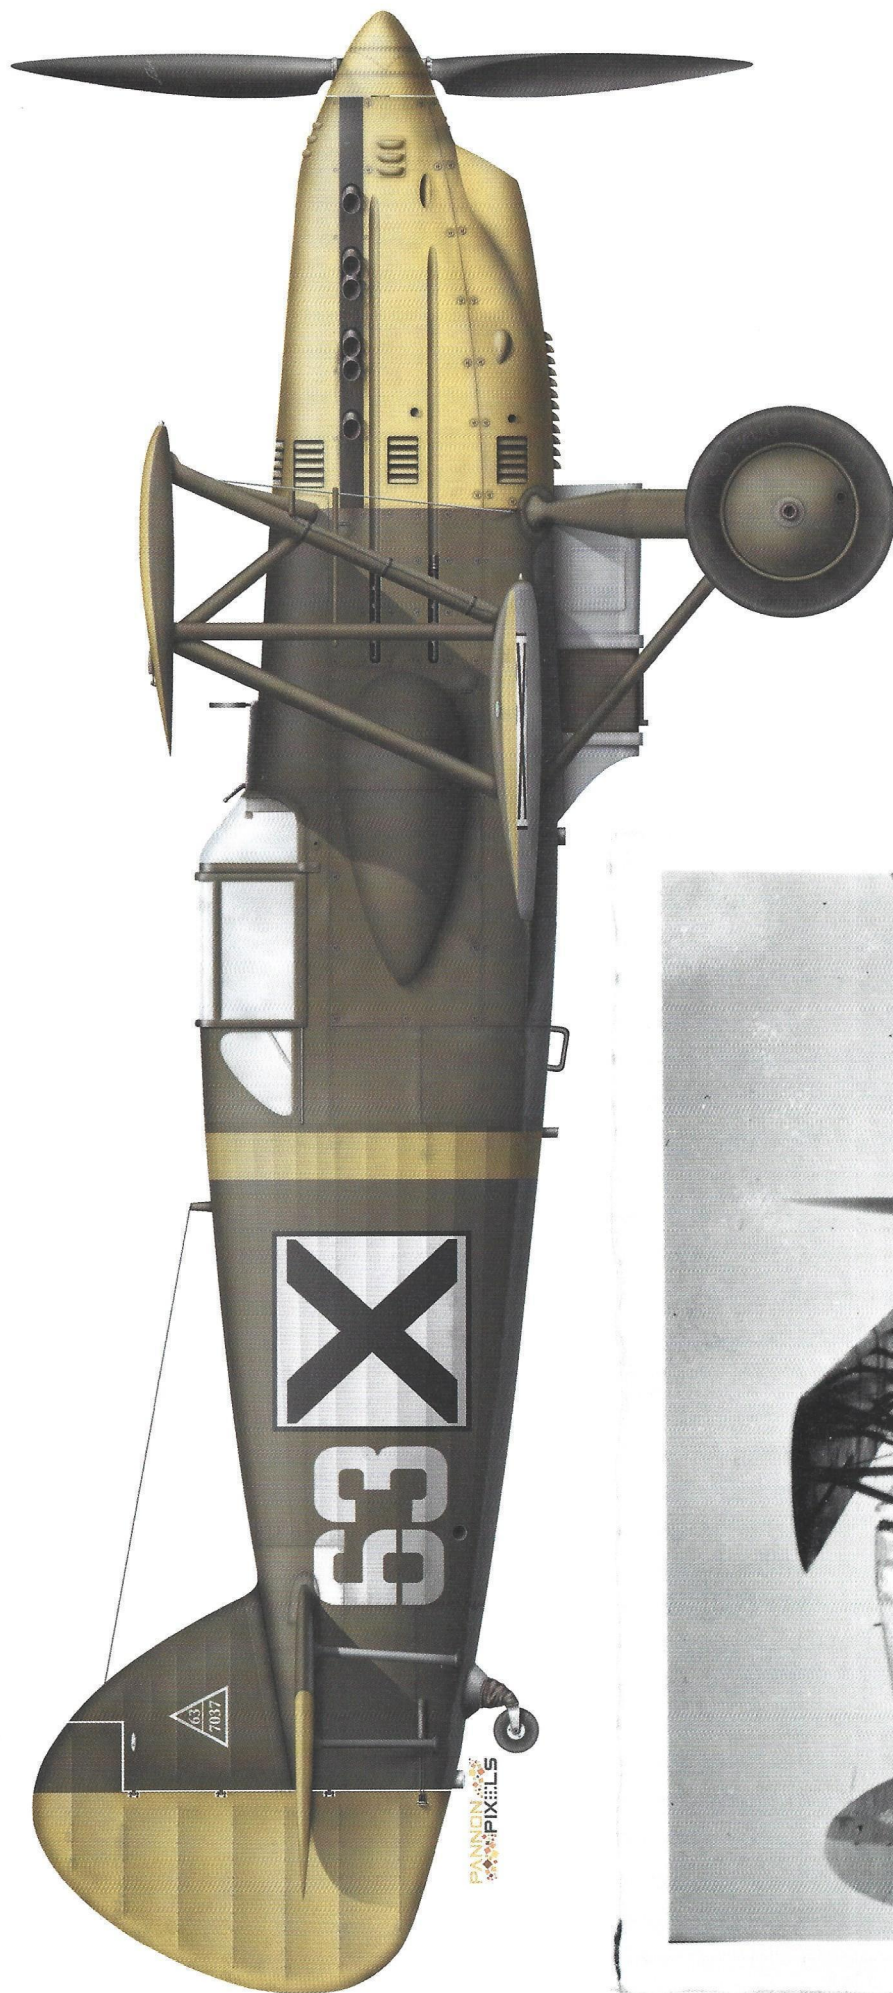
Avia B.534-IV Dogan, 63/7037, 1st Army Air Polk, Bozhurislite, May 1941. Camouflage colours: Czechoslovak khaki green on upper surfaces, over light grey, or shiny metal (silver dope) on under surfaces. St. Andrew cross type VNVV marking on fuselage sides and wing surfaces, in six positions. Yellow spinner, engine cowlings, upper and lower wingtips, rudder and elevators. Narrow yellow mid-fuselage ring. White serial number on rear fuselage.

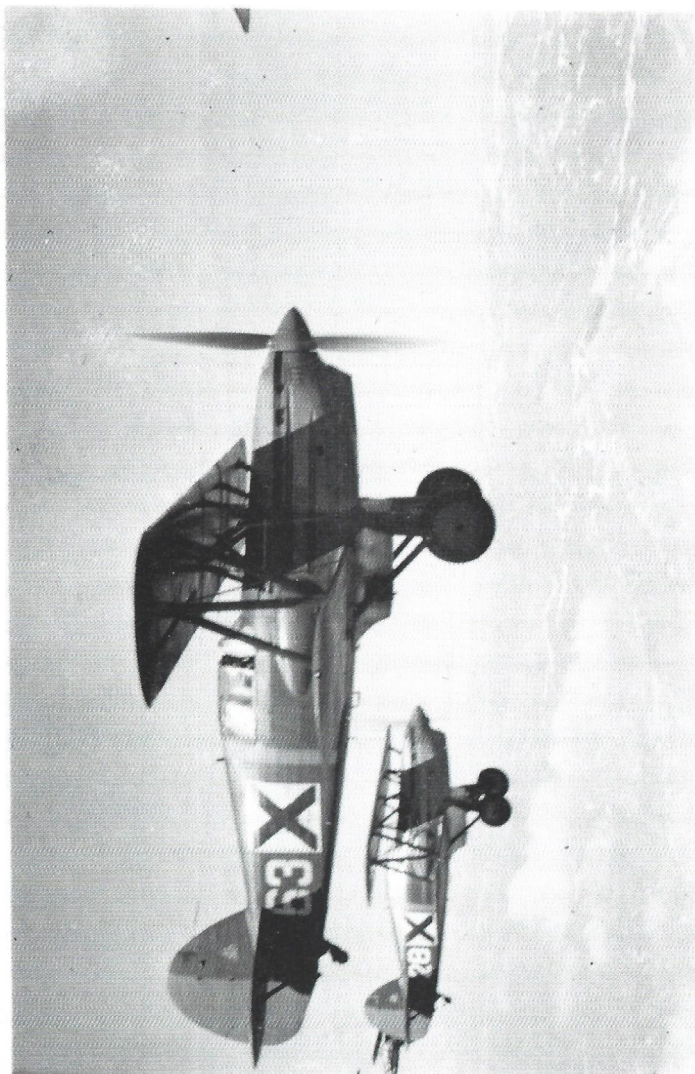
A Dogan flight made of at least six machines cruises in Bulgarian airspace – the element where the aircraft naturally belongs to. Both identifiable Avia fighters, Nos. 63 and 28, wear full Axis recognition features, consisting of yellow spinner, engine cowlings, mid-fuselage band, rudder and elevators (curiously, the rearward tapering flash is missing). These identification markings were implemented shortly before the Axis' anti-Yugoslav Campaign of early April 1941.
